# PROPERTY INSPECTION REPORT

**Concerning:** 123 Anyplace Lane, Hometown, Texas

**By:** Jim Luttrall - License #3779

1/18/2010

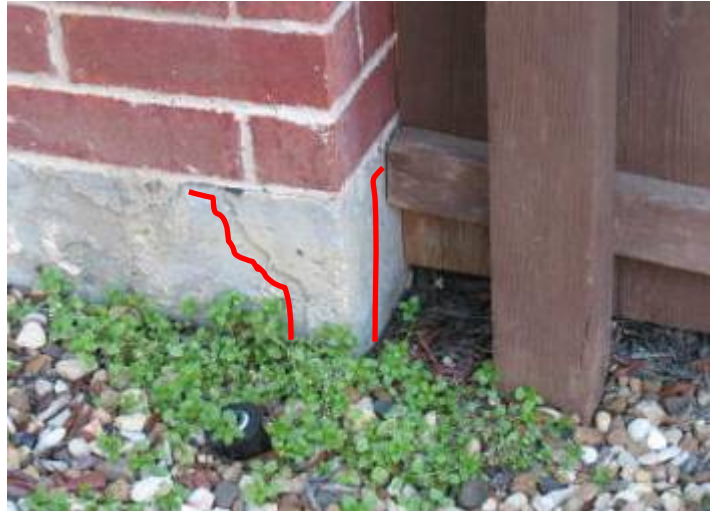
- The foundation appears to be performing its intended function at the time of the inspection.
- Large tree(s) are near the house foundation. You should consider removal of tree(s) or the installation of root barrier to reduce possibility of damage to house foundation from tree roots and moisture removal.
- I observed cracks sometimes referred to as corner or wedge cracks at one or more outside corners of the slab foundation. While not structurally significant, I recommended that you fill these cracks to deter termite activity.

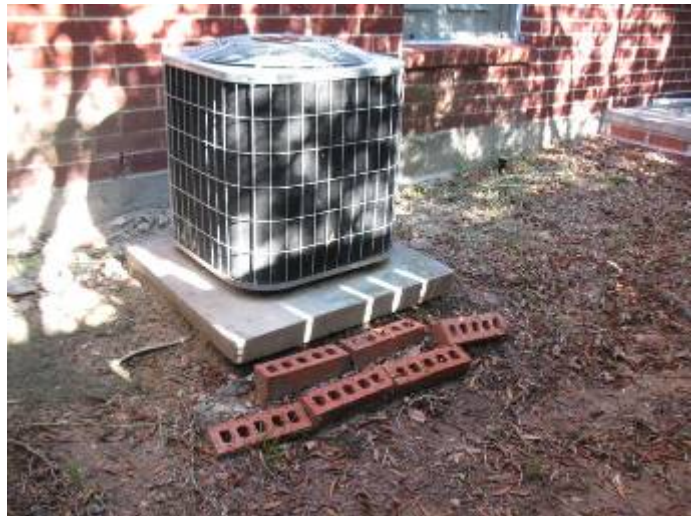
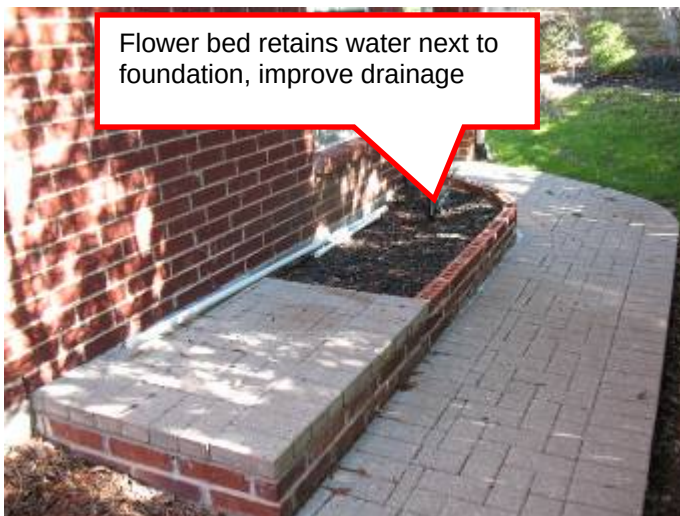
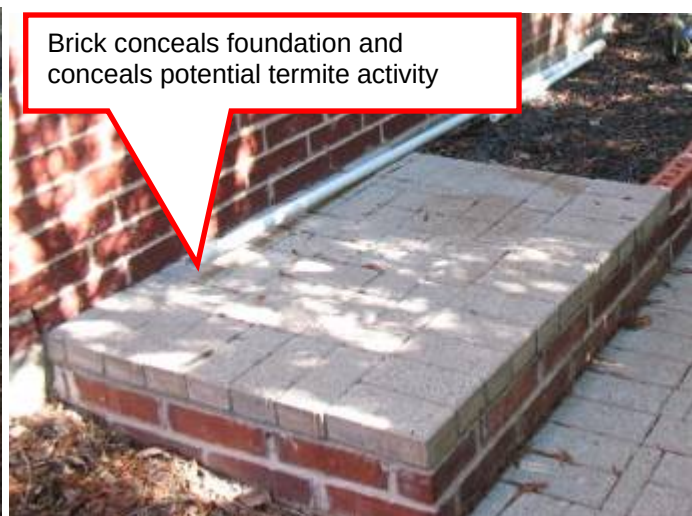
- The soil level is too high around areas with brick siding. Code and common industry practice requires a clearance of 4 inches from bottom of brick veneer to soil. High soil level near brick siding promotes termite activity.
- Flower bed perimeter bricks/timbers hold water near house.

- Some erosion noted at the air conditioner on the south side of the house. This area needs to be stabilized and the concrete pad leveled.

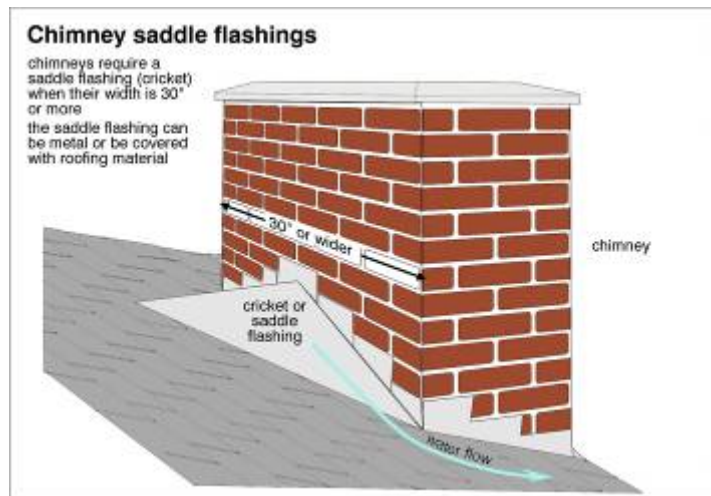
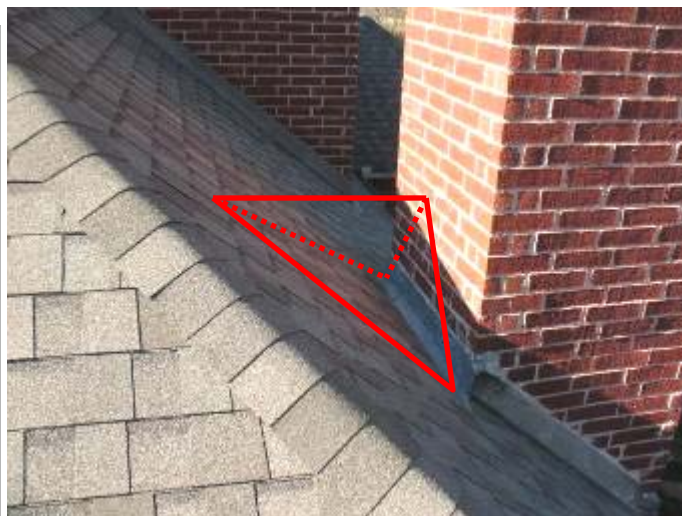
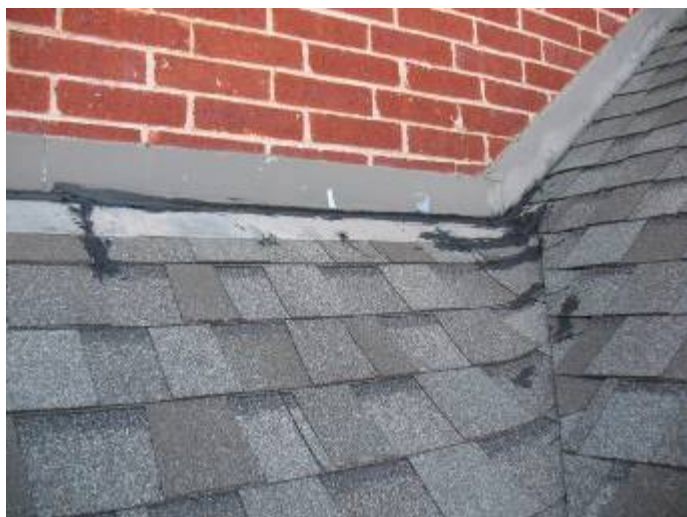
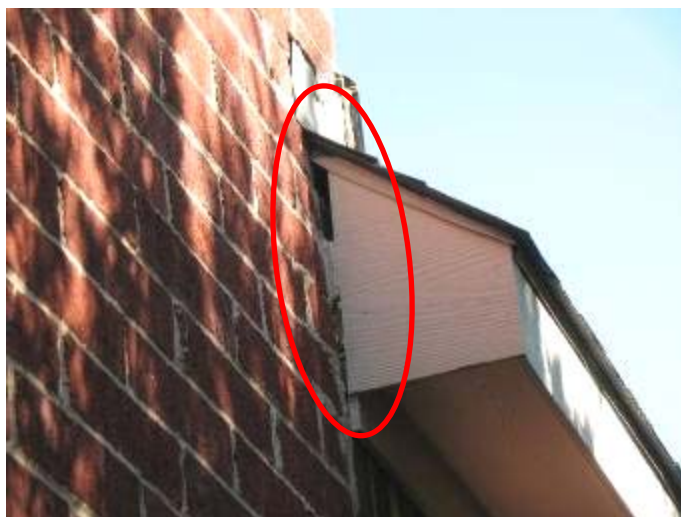
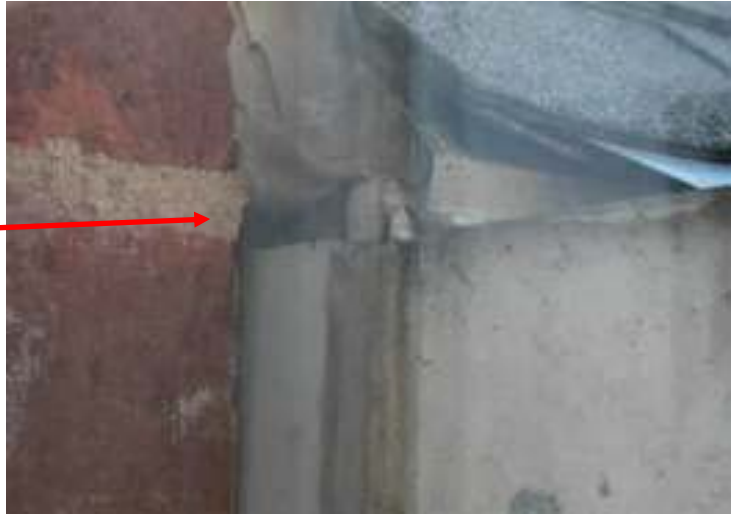
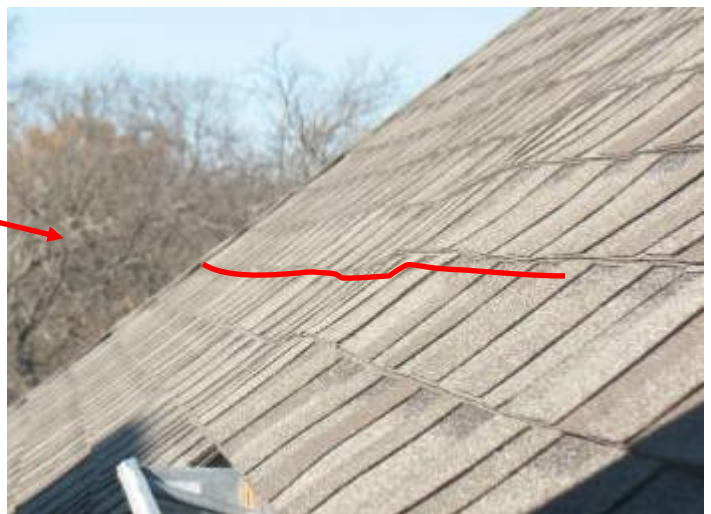
- Roof tar repairs observed around valley on north side of house which is indicative of past leaks. Tar is an improper repair and should never be used on top of a shingle roof, have a professional investigate and perform proper repairs as needed.
- Gutters need general maintenance, cleaning out debris / securing to fascia board / tilting toward drains, seal leaks, / etc.

- There are a few locations where there are gaps between the roof and trim or adjacent walls which should be sealed to exclude pests.
- Sag(s) in roof decking observed over garage. Probable cause from improper/inadequate framing in attic.
- Chimney is larger than 30 inches wide without a cricket present on back side to reduce chance of water entry during heavy rains, recommend addition of chimney cricket when new roof is applied. No apparent problems noted.

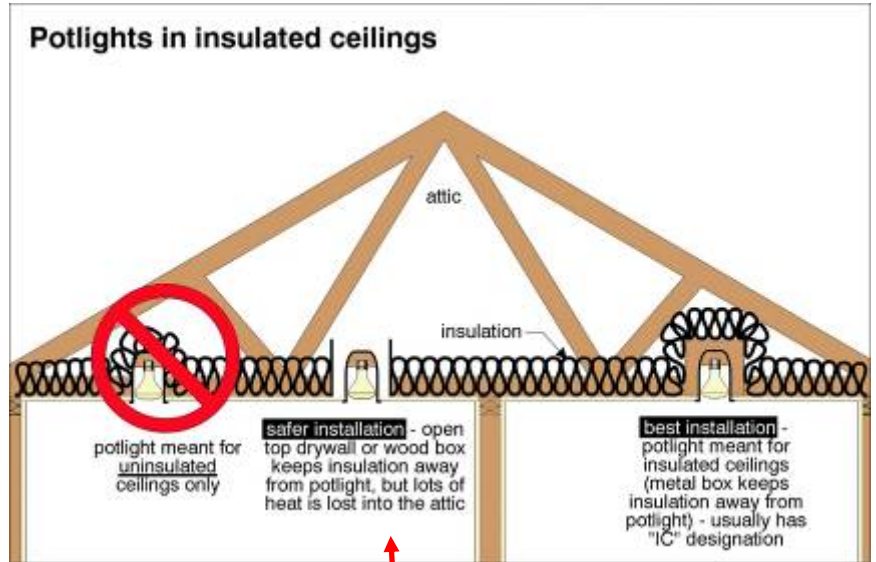
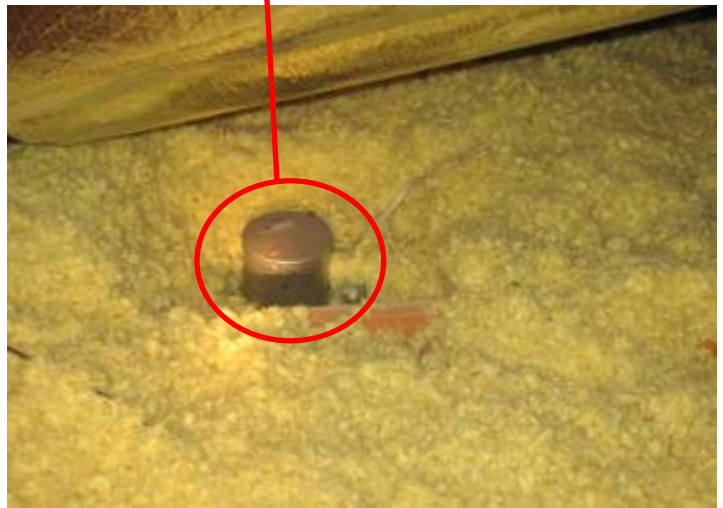
**Air sealing key points**  
Chases and common by-passes

- Recommend sealing/fire stopping all open chases in attic down to living area below. Specifically noted at the south lower attic entrance by the tank-less water heater but other areas may be present. Have the insulator check and repair as needed.
- Insulation not properly positioned/missing or compressed in several areas in the attics.
- Vertical sections of insulation are missing or have fallen down off interior walls in attic. Specific areas noted in front lower attic beside tank type heater and behind duct work in same attic.
- Improper floor decking in attic observed, mainly over garage. The material is not rated for use as flooring in this application leaving the flooring weak.
- Inadequate attic walkway to mechanical equipment in upper attic. There should be a solid walkway from the ladder to the equipment platform in the upper attic.

- Recessed light fixtures (Pot Lights) are not insulated but appear to be IC (Insulation Coverage) rated. Have electrician verify that the fixtures are properly rated for coverage before having insulation issues addressed and proceed based on his findings. (see diagram below)
- There is a cooking pan located in the south part of the attic over the master bedroom that should be removed.

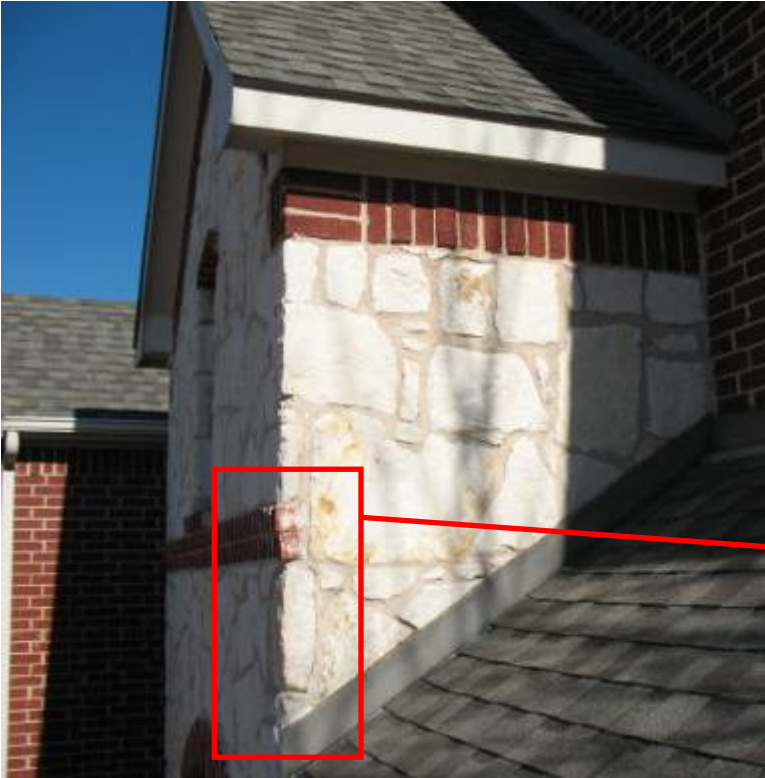
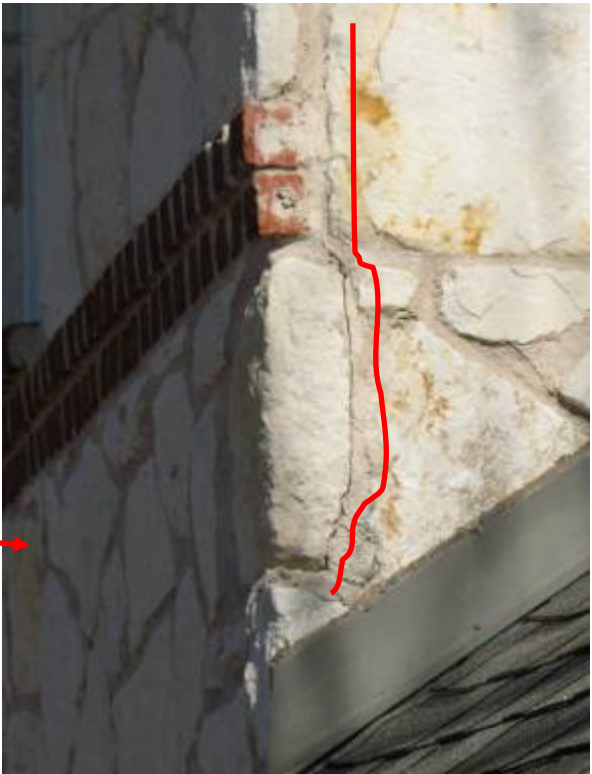
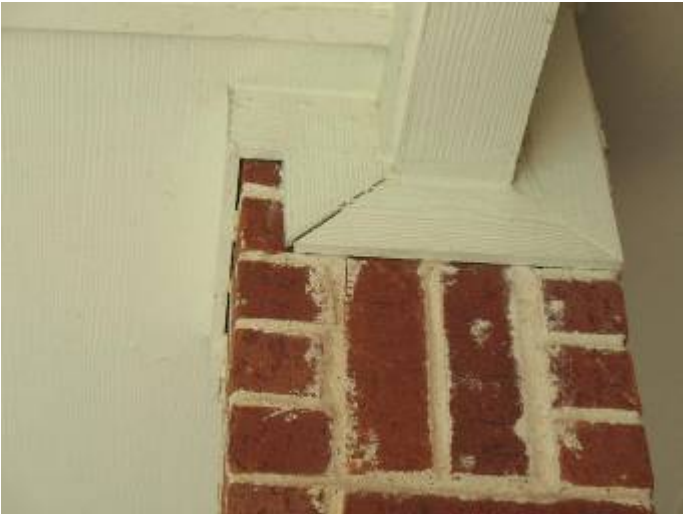
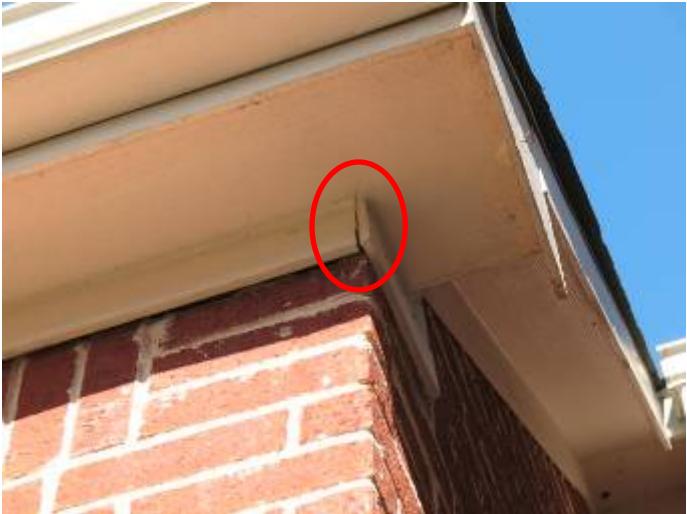
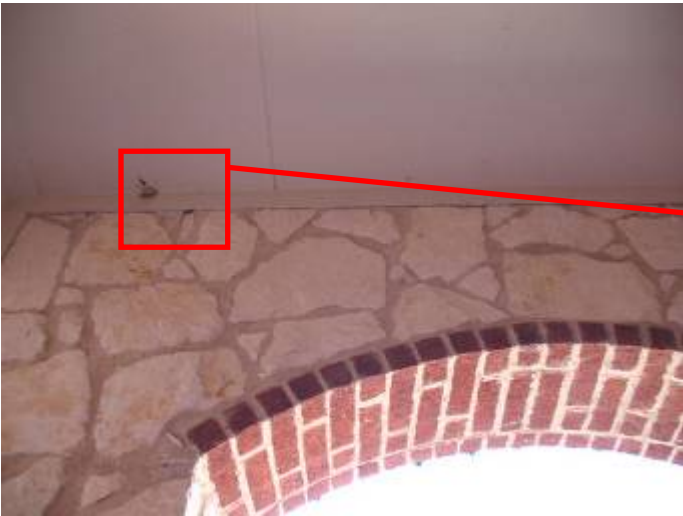
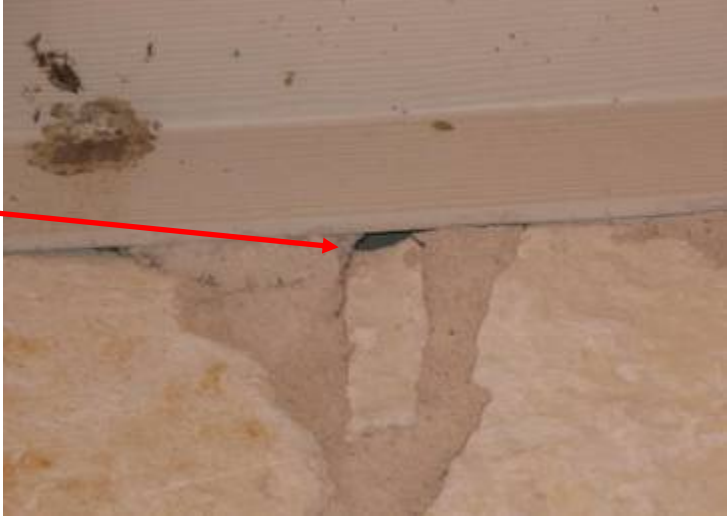
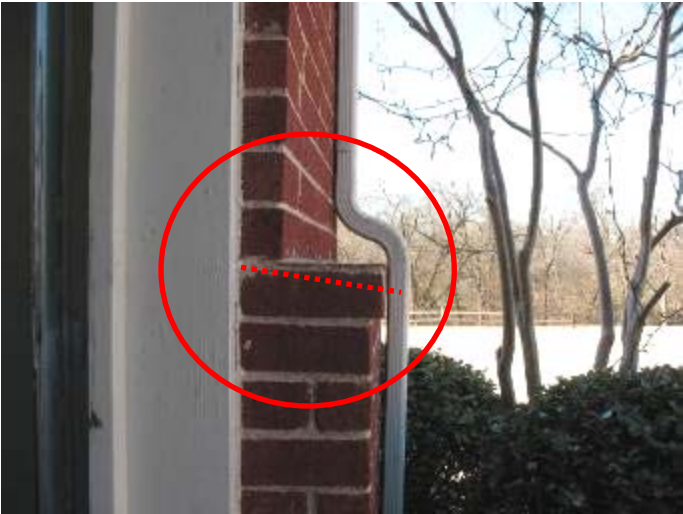
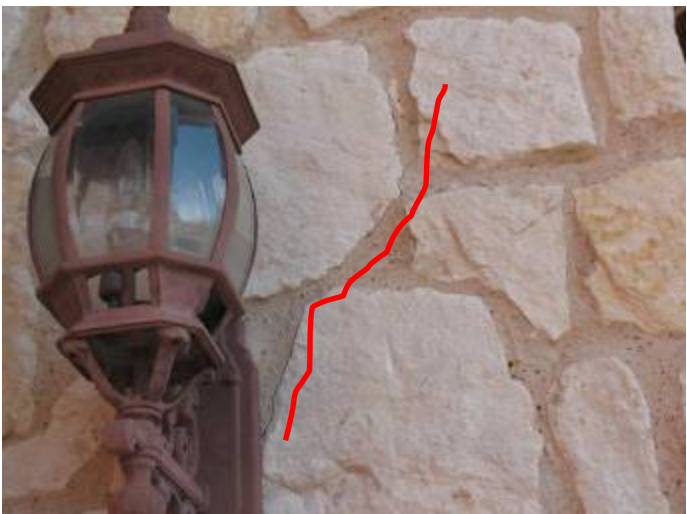
- Sag in header over garage door and cracks in brick work; an indication of improper/inadequate framing. Have a competent brick mason and/or carpenter examine and determine correct repair.

- Water damage to base of cabinet below sink in master bath and kitchen.
- Frieze board separation at one or more corners of house and some gaps in trim or stone work that should be sealed to exclude pests.

- Cracks noted in exterior brick/stone facade. The cracks do not appear to be structurally related but rather an issue with application craftsmanship.
- Bushes / trees / foliage should not contact siding of house to prevent wood rot and insect access

- Evidence of long term water leakage outside master bathroom.
- The brick ledge/shelf is not properly sloped to shed water at the garage wall decorative banding.

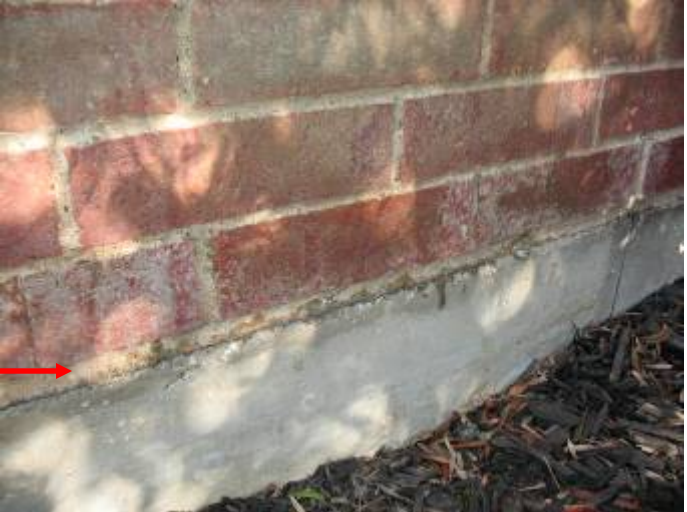
Staining from  
moisture from  
master bath

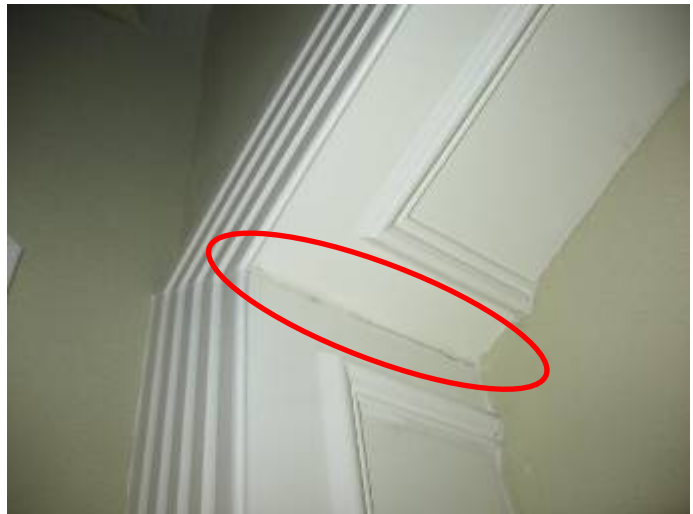
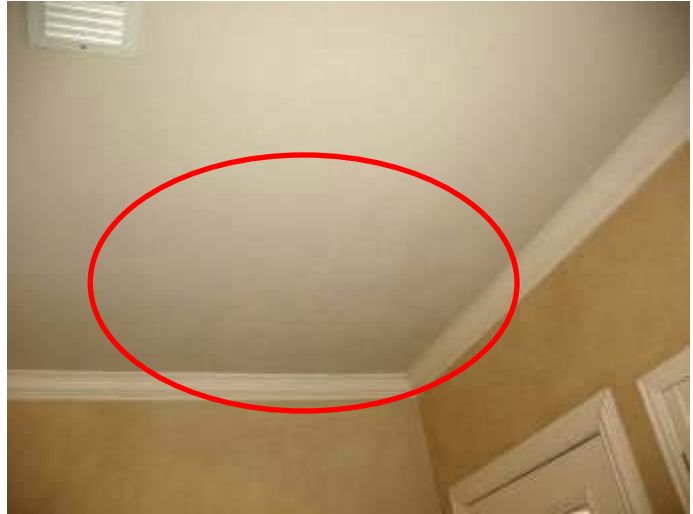
- There are cracks and nail pops in the ceiling in various locations. This is mainly a cosmetic issue with no apparent structural implications.
- There is some evidence of water damaged flooring at the north side exterior door. (See note in Door section below)
- There are blemishes in the ceiling of the hall and breakfast room from past repairs.

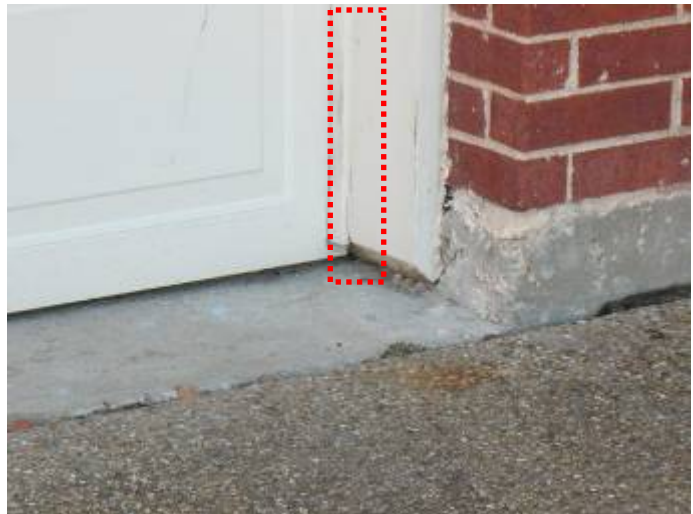
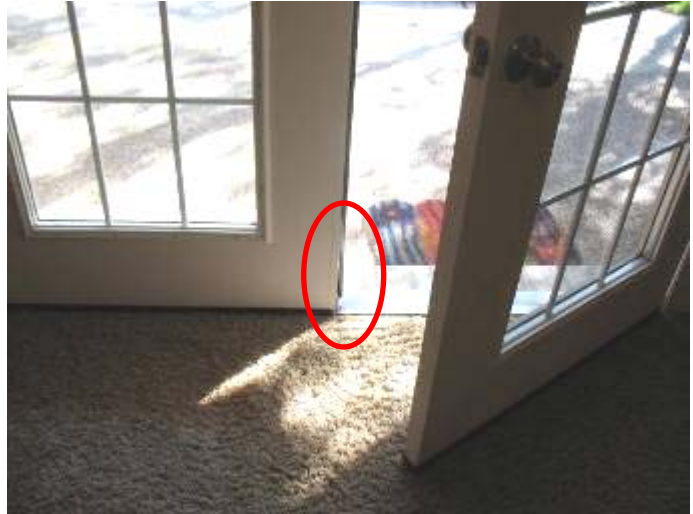
- Garage doors equipped with openers should have door locks rendered inoperable.
- Gaps at bottom corners of overhead garage doors will allow rodent entry. Recommend closing gaps. Metal flashing would be an economical choice that is also weather resistant.
- The friction latch is missing on one of the office doors.
- The rear exterior doors need adjustment to seal evenly and the pin does not work properly (stuck) at the master bedroom.
- I recommend a full coverage storm door to help protect from water entry at the exposed north side exterior door.
- The door and frame on the north side exterior and overhead garage doors are in need of repair and painting to protect from weather damage.

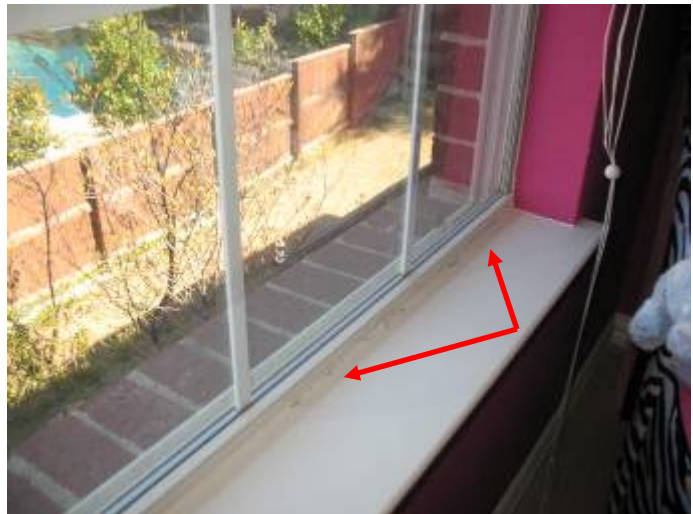
- There are missing or damaged screens.
- Water stains/ damage noted on interior of one or more window jambs. Likely from condensation on metal window frames in cold weather.

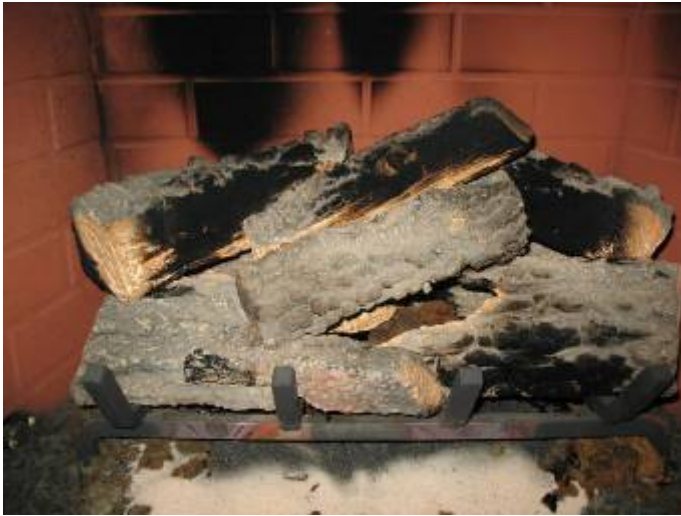
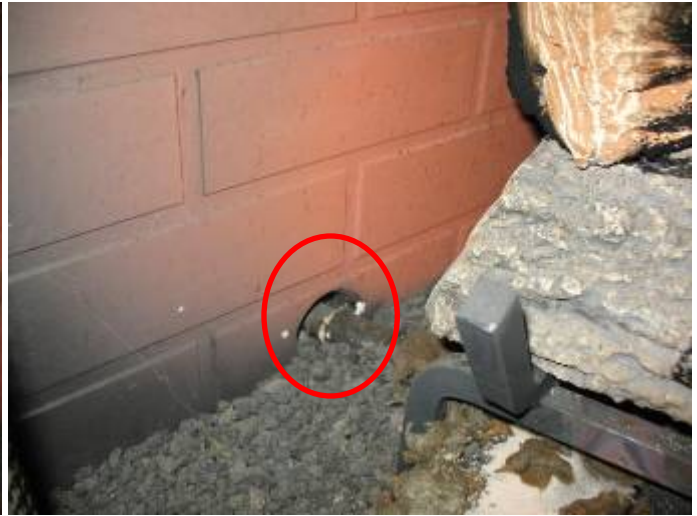
- Soot build-up in fire box and/or flue, should be cleaned by a qualified chimney sweep.
- Soot build up on faux logs indicates improper combustion - air/fuel mixture. Recommend service to clean soot and adjust air/fuel mix to reduce/eliminate soot production.
- The gas starter pipe is not sealed with high temperature sealant where it enters the firebox as required to keep embers and fuel gas from entering the wall cavity.

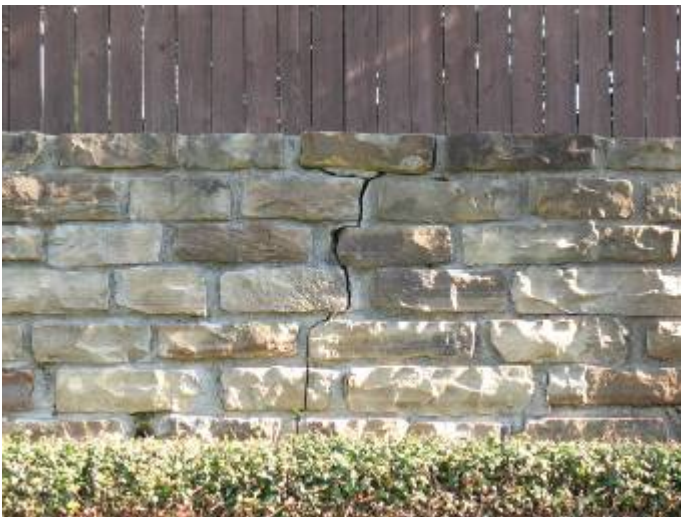
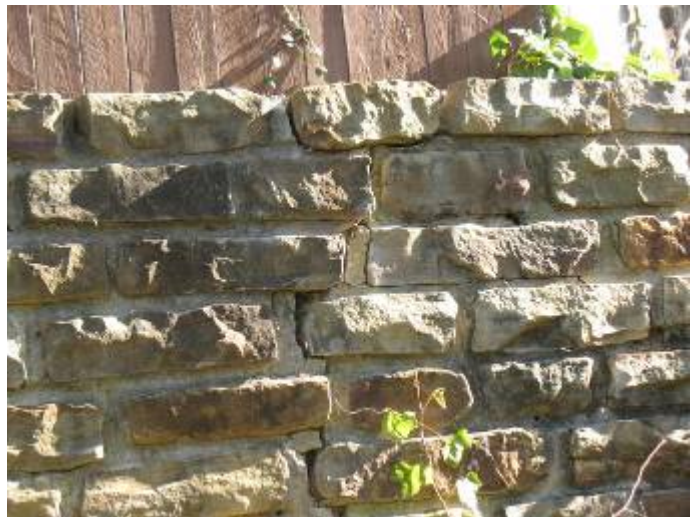
- There is a crack on the rear porch floor.
- The retaining wall at the rear of the property has cracks in several locations and needs repair.
- There is some cracking of mortar joints at planting beds along front sidewalk.

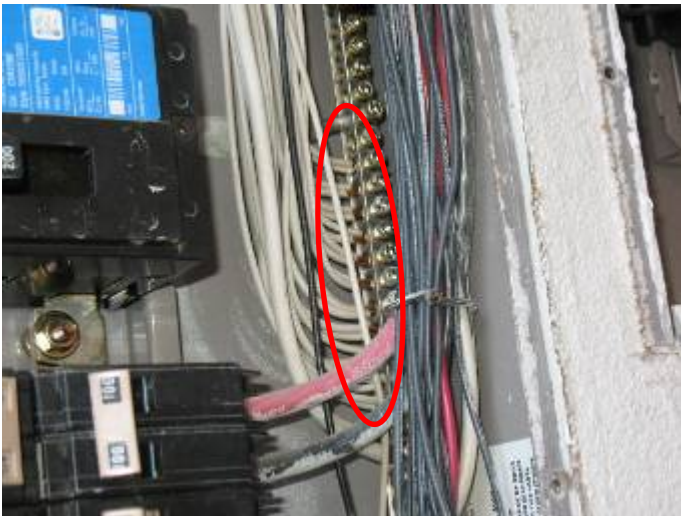
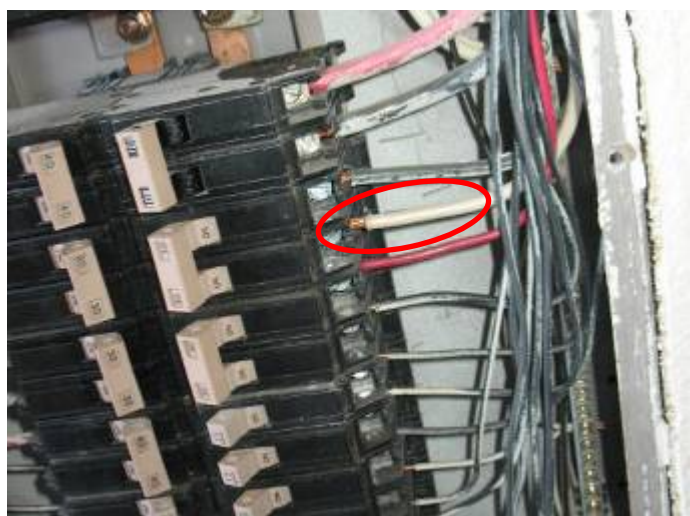
- Inspectors are required to point out that the house does not have AFCI (Arc Fault Circuit Interrupter) breakers for all the circuits or child resistant outlets as required in new construction under the 2008 NEC. While this is not required in this house, it may be a worthwhile safety upgrade.
- As is common in houses of this era, the neutral (white) wires are doubled up at terminals in the panel rather than attached individually to separate terminals as required.
- Observed improper use of normal wire conductor colors. Observed white wire used for other than grounded / neutral. The wires should be re-identified (tape or other permanent means) at both ends.

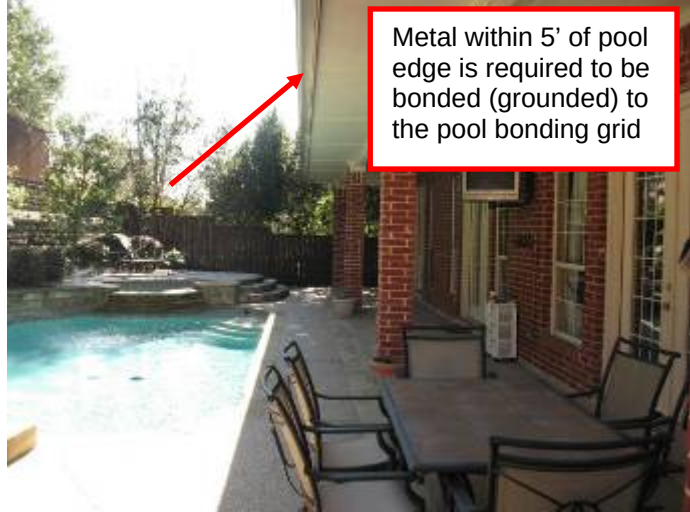
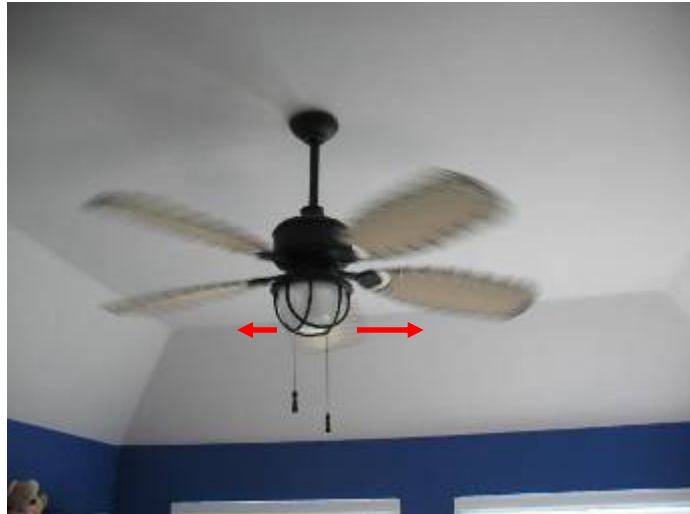
- There was not GFCI protection observed at all required locations, including but not limited to; all bathrooms, all kitchen counter top outlets, wet bar locations, all exterior outlets, in garage, etc. This condition is a recognized safety hazard. See <http://www.cpsc.gov/cpscpub/pubs/99.html> for more information. Specifically, the exterior mini refrigerator is not protected; the outdoor outlet at the TV and the downstairs bathrooms will not reset. Have a qualified electrician correct. Also, have the electrician verify that the circuit to the TV is properly connected and the wire size matches the over-current protection device (breaker.)

- Missing cover plate screws in various locations.
- Have the electrician verify proper GFCI protection for all pool side lighting (even low voltage) as well as bonding of the metal components near the pool (i.e. the rain gutter, and grill.)

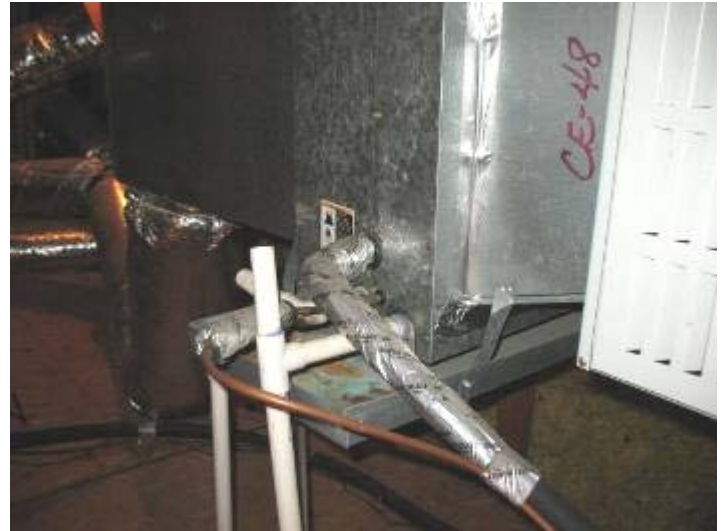
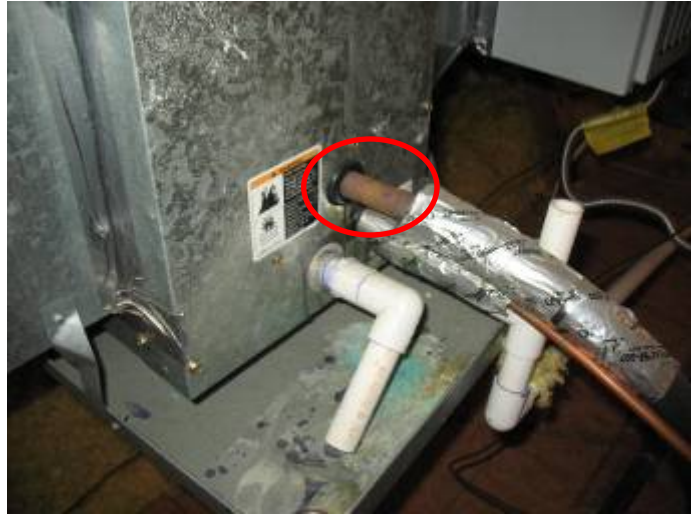
- The primary drain line is not properly trapped and vented. This results in condensation not draining properly and loss of conditioned air to the attic.

- The secondary drain line is not trapped and is blowing (or sucking) conditioned air into the attic. A trap should be installed. I also recommend priming the trap with mineral oil or equivalent to prevent loss of trap seal to evaporation.

- Heavy rust noted in secondary pan indicates the primary drain has been clogged and notes a general lack of maintenance. A damaged pan should be replaced to prevent damage to building structure below.

- Section(s) of suction line insulation missing in attic near coil. Warm attic air condenses on cold suction line/expansion valve and drips condensation.

- Insulation / debris in drain pan should be removed to prevent blocking of drain.
- Recommend sealing exterior where AC lines enter house.
- South unit not level, needs to be level for proper operation.

4. Install a 3" trap in both the primary and secondary drain lines as close to the unit as practical (see figure 9). Make sure the top of the trap is below the connection to the drain pan to allow complete drainage of the pan.

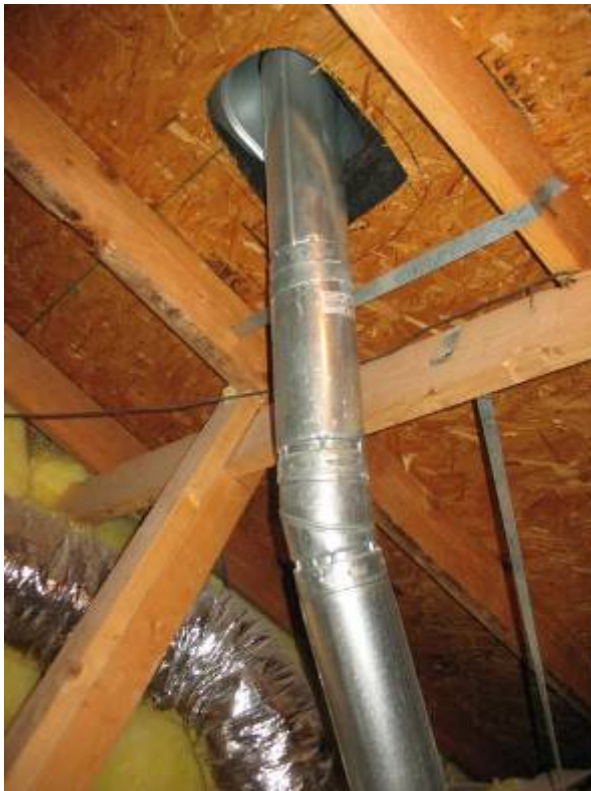
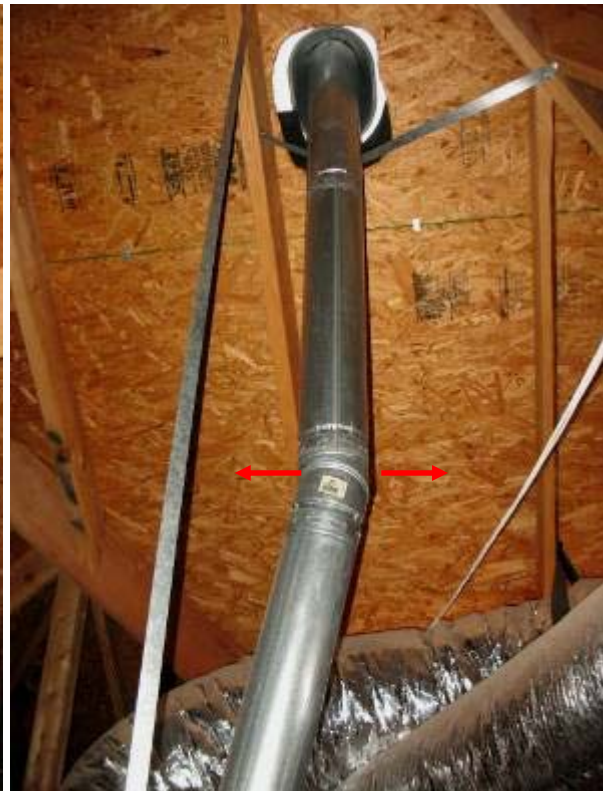
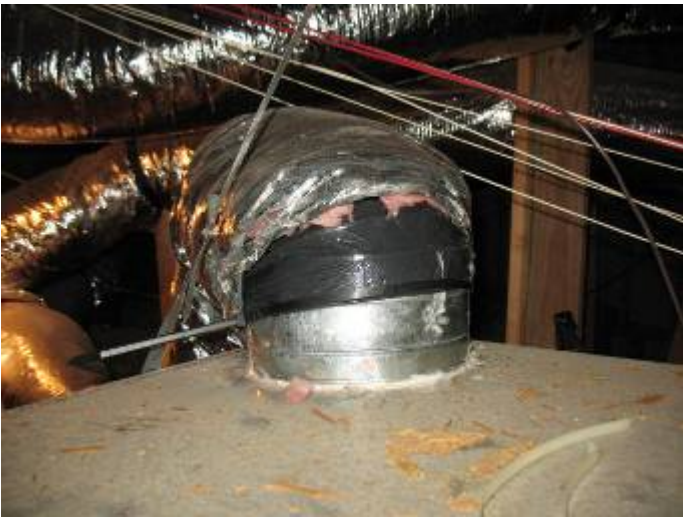
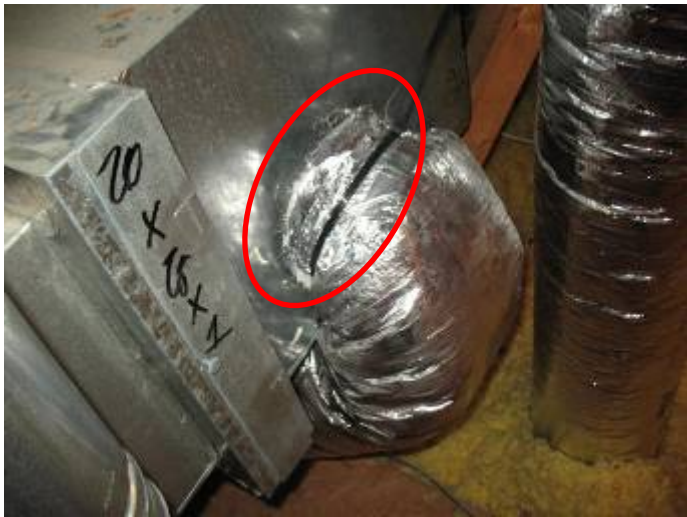
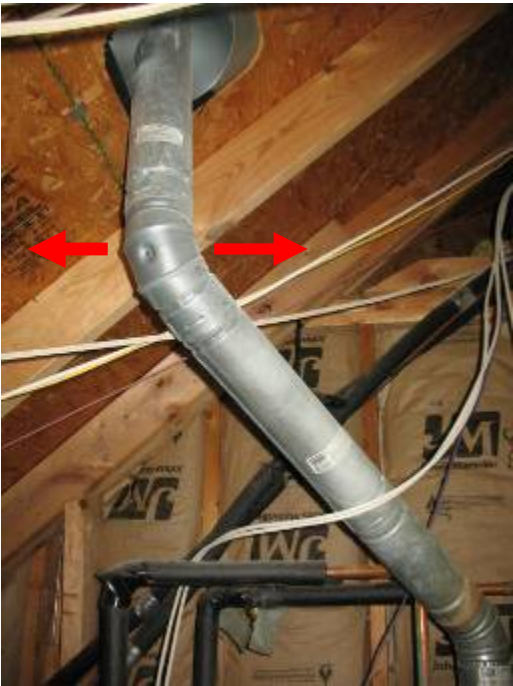
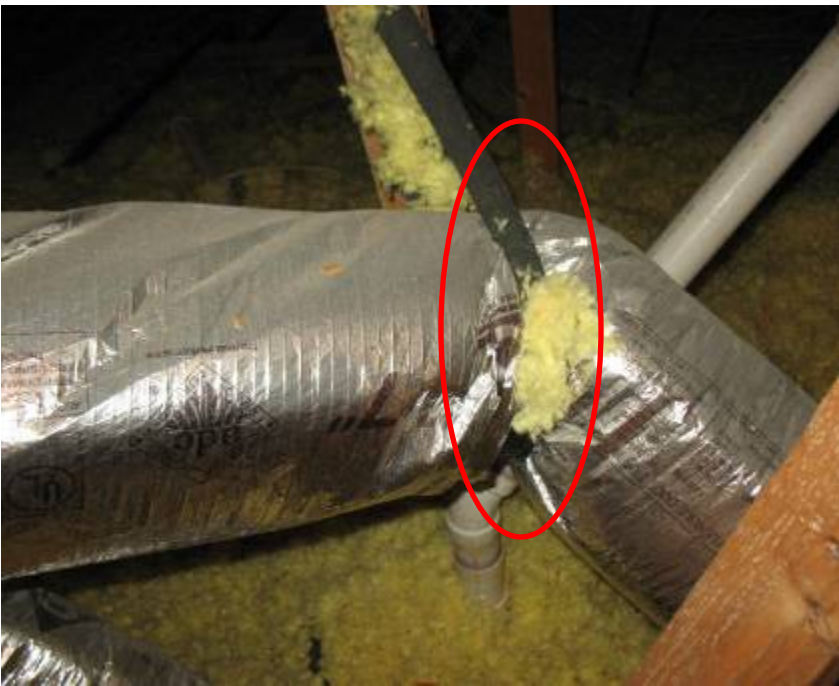
- There is excessive air loss at coil around drain and refrigerant line connections.
- The ducts are loose at the plenum in the attics.
- One or more areas where duct straps supporting flex air ducts in attic are restricting airflow.
- Vent pipe(s) is (are) not properly secured (strapped) in place on all three furnaces and both water heaters. The vent pipes are not plumb (vertical) on the roof top. The vents should be straightened and strapped in place to prevent movement in any direction while maintaining a minimum of one inch clearance to combustibles.

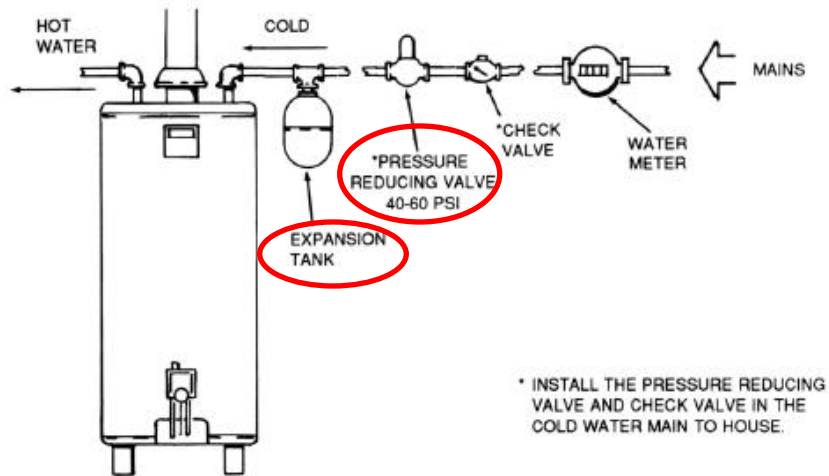
- Pressure is too high. Modern standards call for a pressure regulator to be installed along with an associated expansion tank and valves as may be required in order to protect the building pipes and fixtures when the supply pressure exceeds 80 PSI.
- Toilet is loose at floor on the north upstairs bath and at the half bath downstairs.
- Upstairs north toilet leaks water at the flapper valve. I recommend replacing the valve and seat.
- South hose bib leaks water at the stem washer.
- The tub spout needs to be adjusted to seal against the wall on at least two of the tubs.
- The north upstairs bath room sink is missing the aerator and splashes water onto the cabinet and floor.

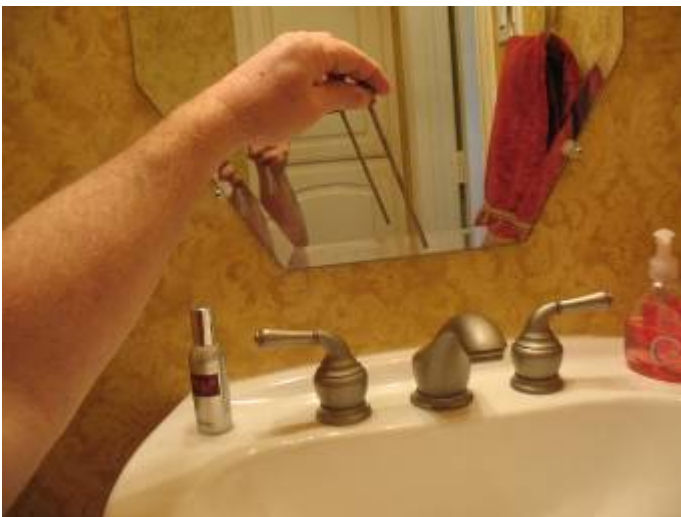
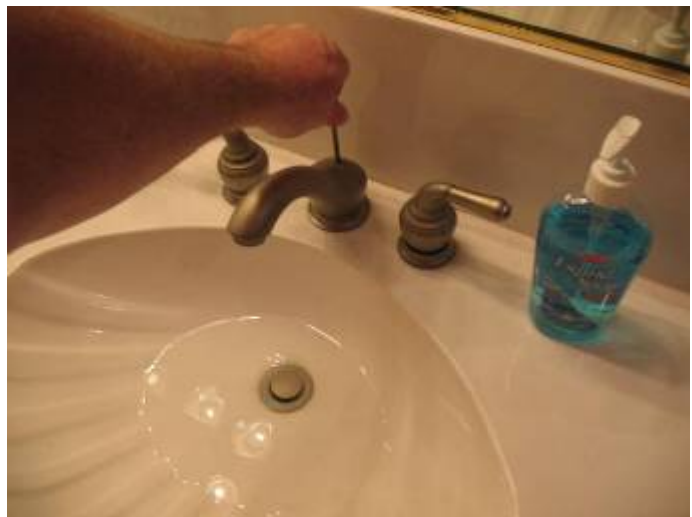
- Drain stopper of one or more sinks is missing or needs adjustment.
- Slow drain at both upstairs tubs and sinks, likely hair on drain stoppers.

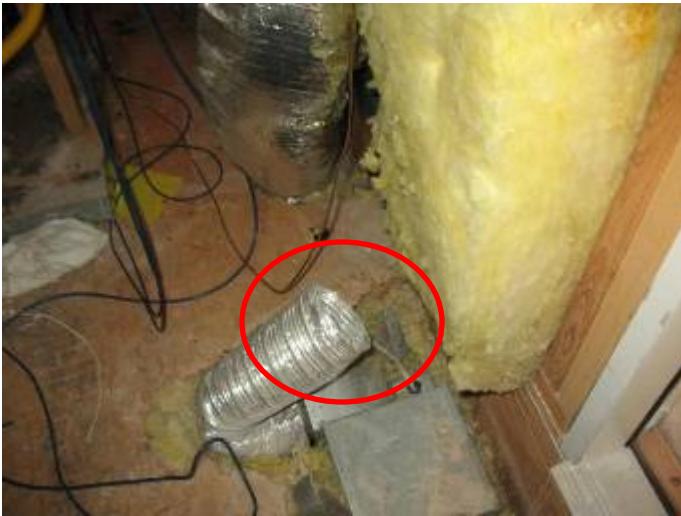
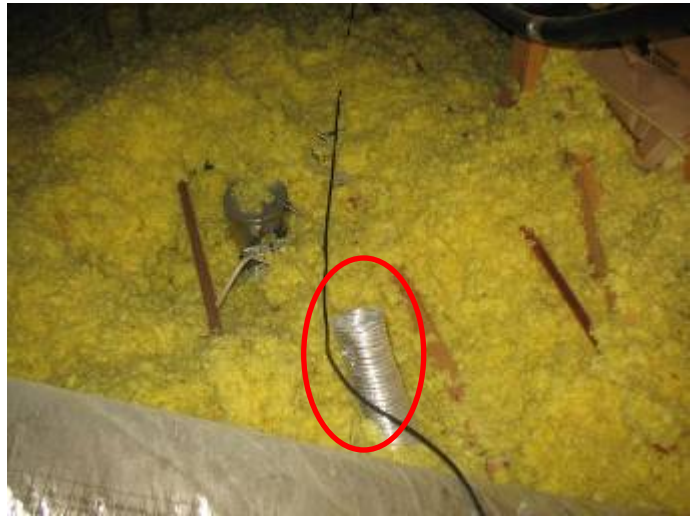
- Improperly vents into attic. Should vent to exterior.

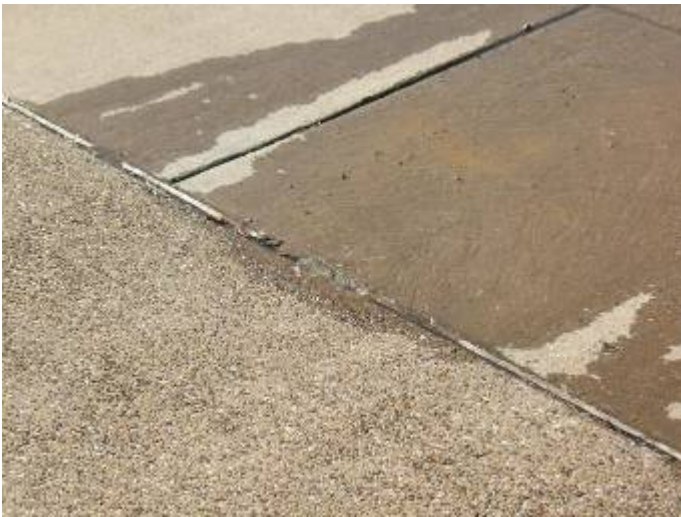
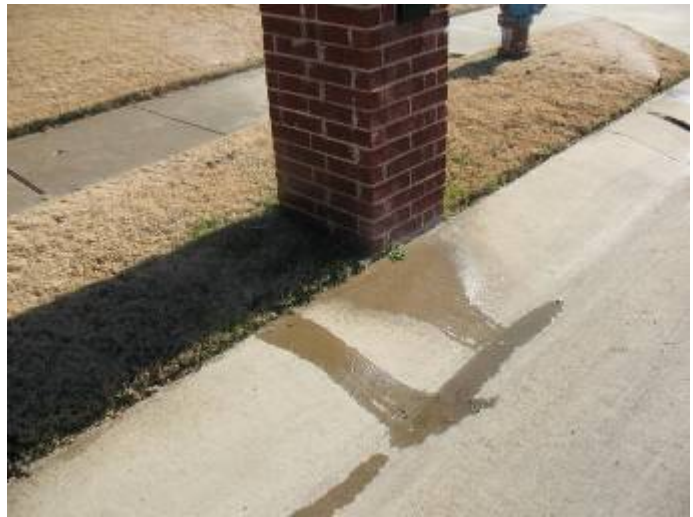
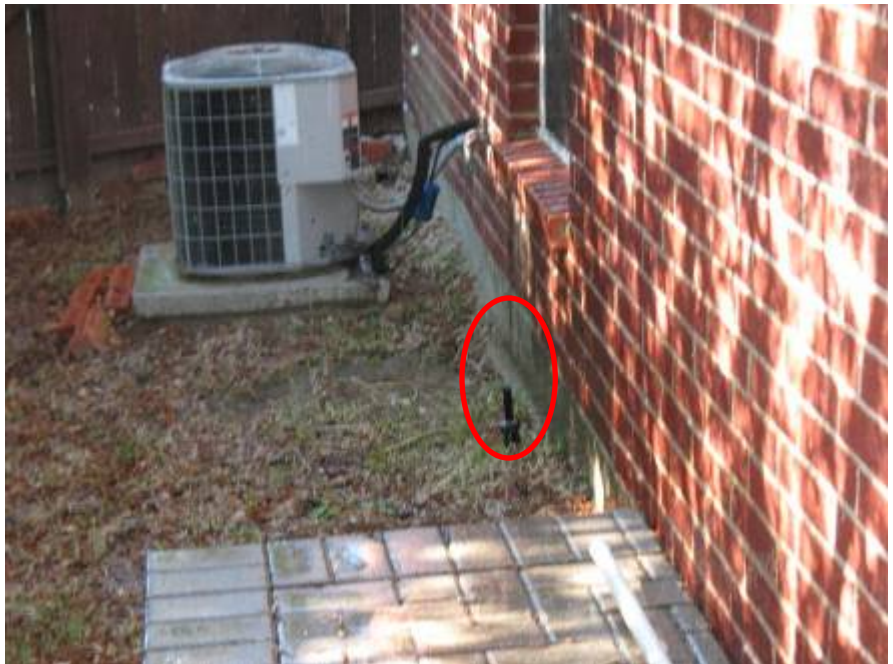
- The sprinkler system needs to be adjusted to prevent spraying water directly on the house, fence, and/or wasting water on street and walks.
- Broken underground pipe at front side yard which disables most of the heads on that zone.
- Broken head or riser noted at front beds and at rear side yard.
- There is no rain sensor.

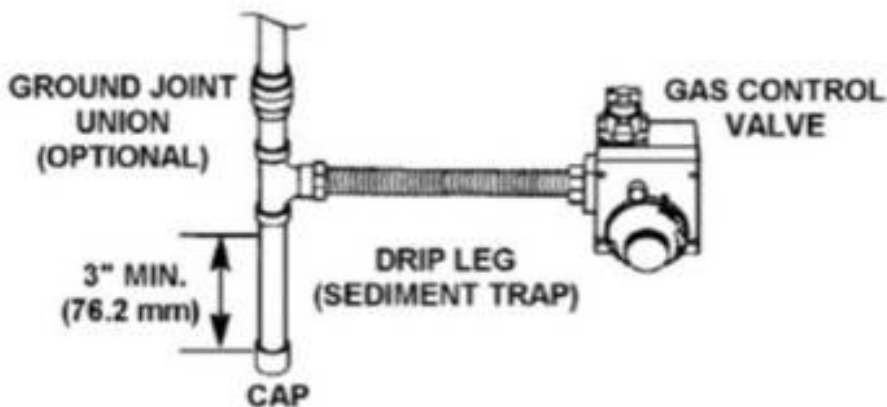
- Sediment traps (Drip legs) are required at furnaces and water heaters. No sediment traps were found at the appropriate locations. The common practice in this area excludes these items, but all common building codes and manufacturers require the presence to protect automatic equipment for safety.
- The exterior gas lines at the meter, pool equipment, grill, etc. should be painted to protect from corrosion.
