# PROPERTY INSPECTION REPORT

**Concerning:** 123 Anyplace Lane, Hometown, Texas

**By:** Jim Luttrall - License #3779

1/18/2010

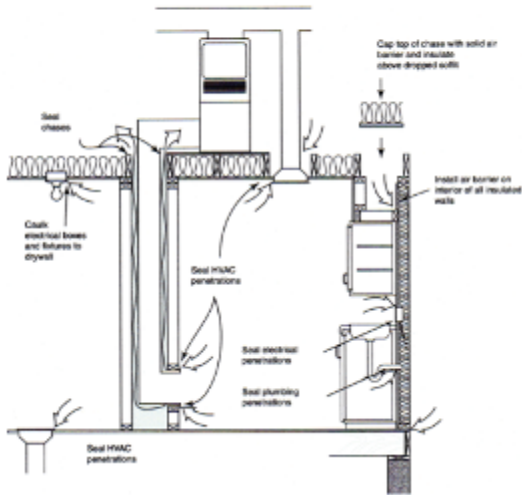
**Air sealing key points**  
Chases and common by-passes

- Recommend sealing/fire stopping all open chases in attic down to living area below. Specifically noted at the south lower attic entrance by the tank-less water heater but other areas may be present. Have the insulator check and repair as needed.
- Insulation not properly positioned/missing or compressed in several areas in the attics.
- Vertical sections of insulation are missing or have fallen down off interior walls in attic. Specific areas noted in front lower attic beside tank type heater and behind duct work in same attic.
- Improper floor decking in attic observed, mainly over garage. The material is not rated for use as flooring in this application leaving the flooring weak.
- Inadequate attic walkway to mechanical equipment in upper attic. There should be a solid walkway from the ladder to the equipment platform in the upper attic.

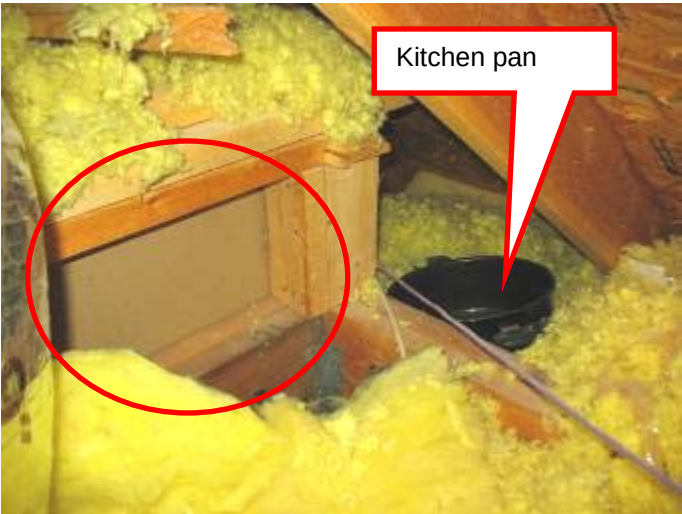
- Recessed light fixtures (Pot Lights) are not insulated but appear to be IC (Insulation Coverage) rated. Have electrician verify that the fixtures are properly rated for coverage before having insulation issues addressed and proceed based on his findings. (see diagram below)
- There is a cooking pan located in the south part of the attic over the master bedroom that should be removed.

Kitchen pan

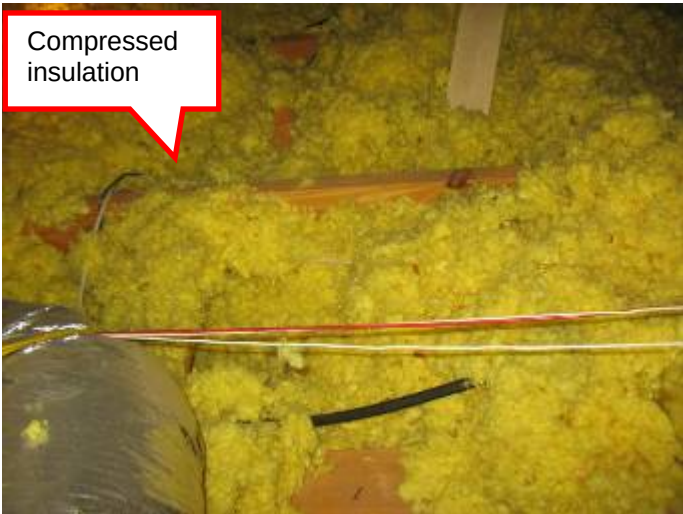
Compressed insulation

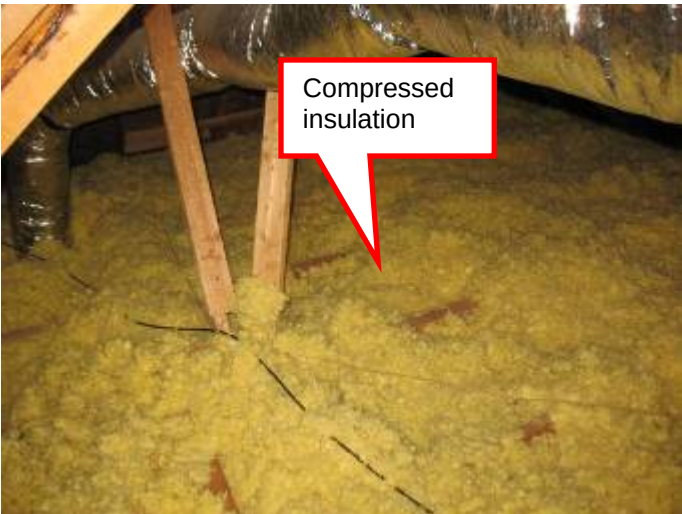
Compressed insulation

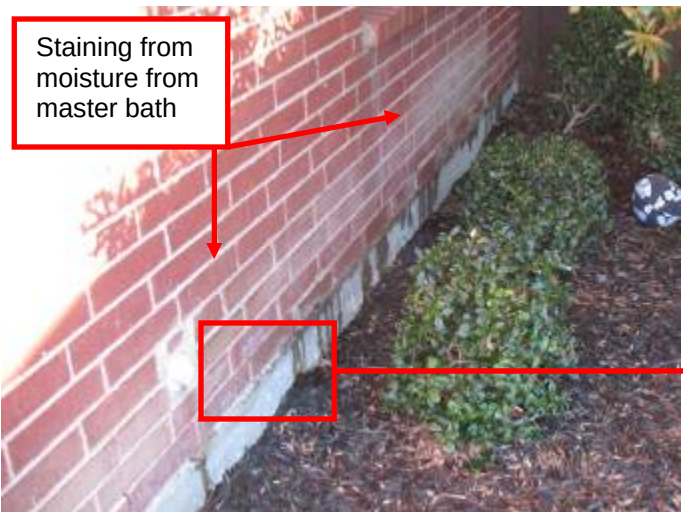
- Evidence of long term water leakage outside master bathroom.
- The brick ledge/shelf is not properly sloped to shed water at the garage wall decorative banding.

Staining from  
moisture from  
master bath

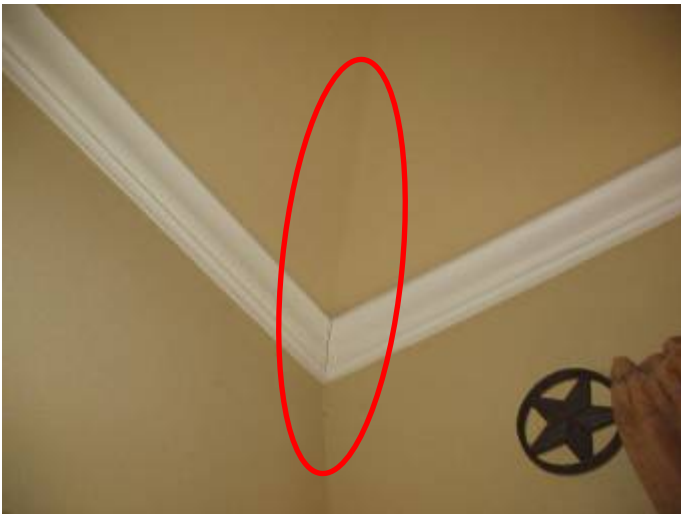
- There are cracks and nail pops in the ceiling in various locations. This is mainly a cosmetic issue with no apparent structural implications.
- There is some evidence of water damaged flooring at the north side exterior door. (See note in Door section below)
- There are blemishes in the ceiling of the hall and breakfast room from past repairs.

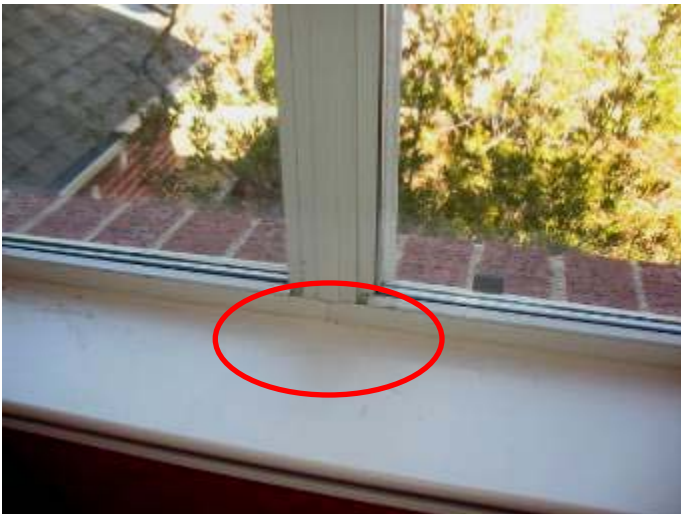
- There are missing or damaged screens.
- Water stains/ damage noted on interior of one or more window jambs. Likely from condensation on metal window frames in cold weather.

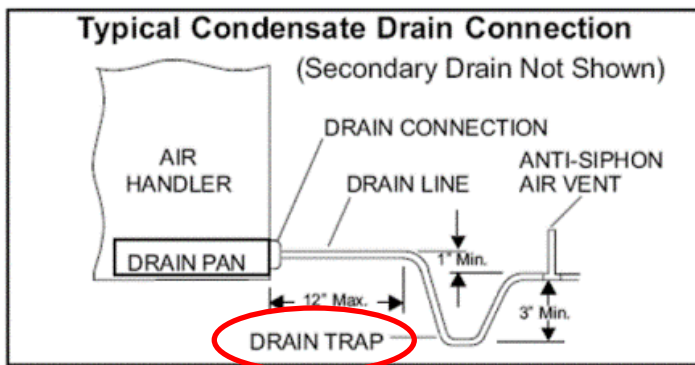
- The secondary drain line is not trapped and is blowing (or sucking) conditioned air into the attic. A trap should be installed. I also recommend priming the trap with mineral oil or equivalent to prevent loss of trap seal to evaporation.

4. Install a 3" trap in both the primary and secondary drain lines as close to the unit as practical (see figure 9). Make sure the top of the trap is below the connection to the drain pan to allow complete drainage of the pan.

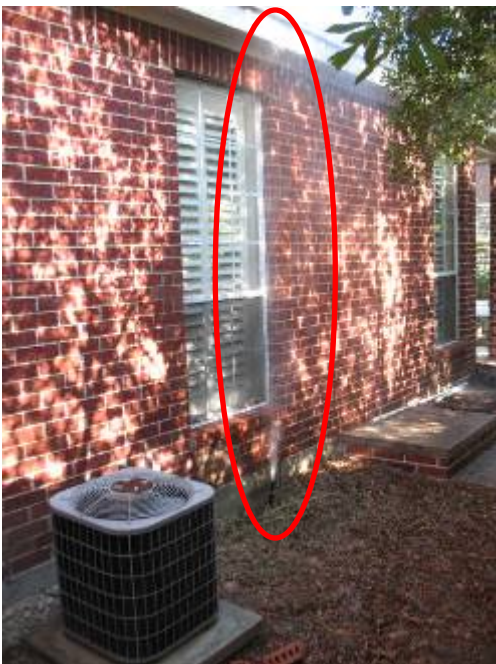
- The sprinkler system needs to be adjusted to prevent spraying water directly on the house, fence, and/or wasting water on street and walks.
- Broken underground pipe at front side yard which disables most of the heads on that zone.
- Broken head or riser noted at front beds and at rear side yard.
- There is no rain sensor.

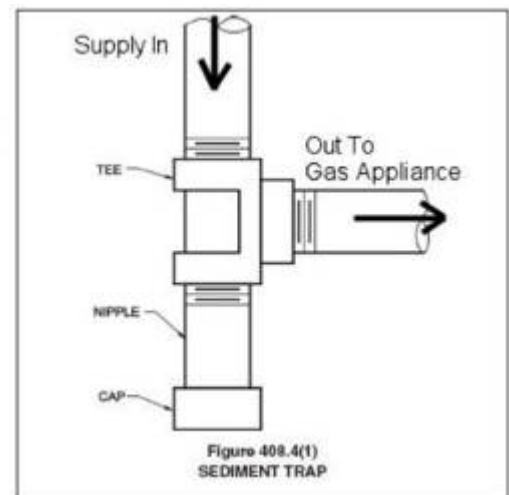
- Sediment traps (Drip legs) are required at furnaces and water heaters. No sediment traps were found at the appropriate locations. The common practice in this area excludes these items, but all common building codes and manufacturers require the presence to protect automatic equipment for safety.
- The exterior gas lines at the meter, pool equipment, grill, etc. should be painted to protect from corrosion.
